TECHNICAL REPORT NO. 3-642

REVIEW OF SOILS DESIGN, CONSTRUCTION
AND PERFORMANCE OBSERVATIONS
OVERBANK STRUCTURE, OLD RIVER CONTROL
APPENDIX B: PUMPING TESTS AND WELL CLEANING
OPERATIONS, 1969-1970

REVIEW OF SOILS DESIGN, CONSTRUCTION
AND PERFORMANCE OBSERVATIONS
OVERBANK STRUCTURE, OLD RIVER CONTROL

APPENDIX B: PUMPING TESTS AND WELL CLEANING OPERATIONS, 1969-70

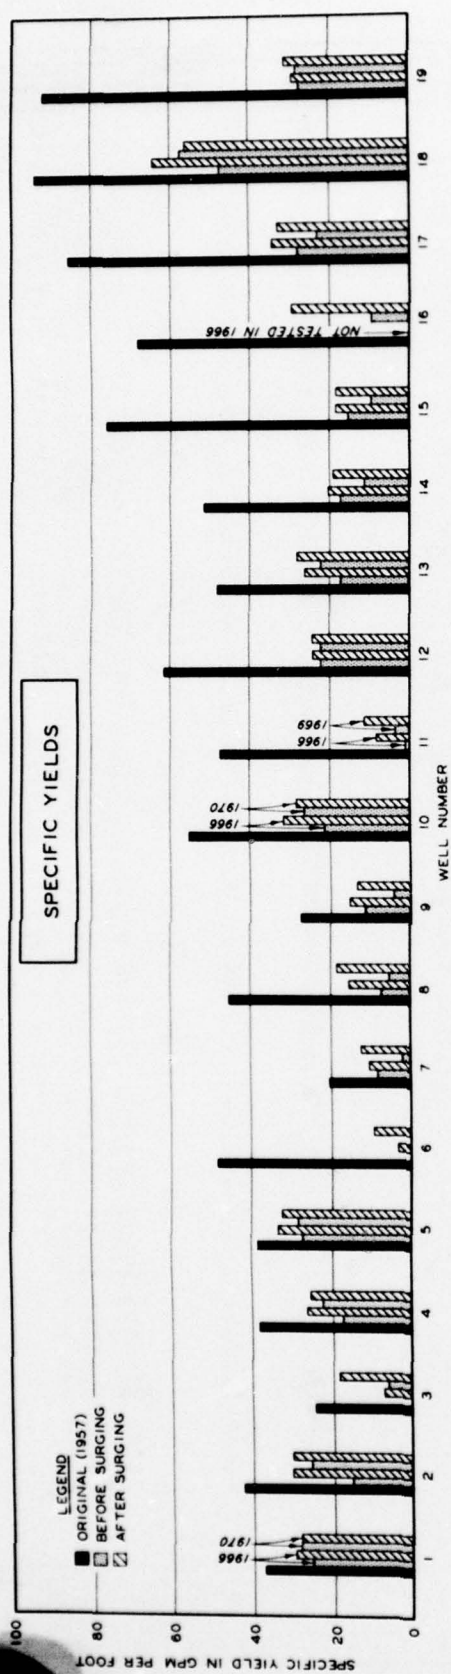
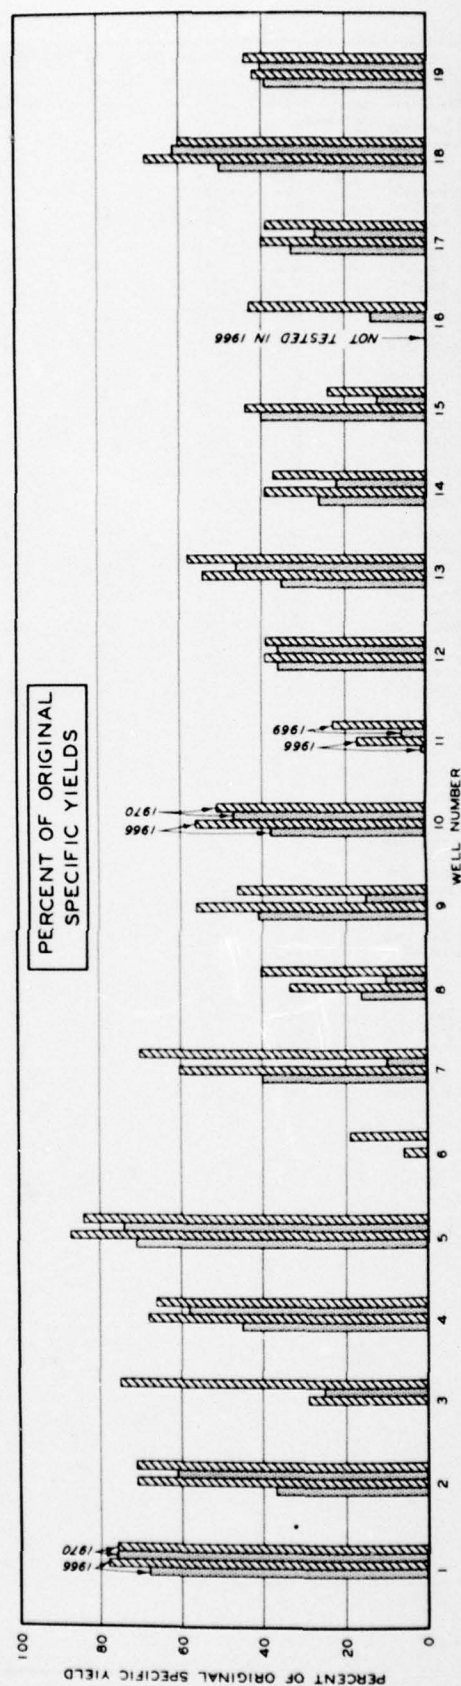
Fig. B2. Comparison of 1957, 1966, and 1969-70 specific yields

Initial 1969-70 pumping tests on the wells indicated an average specific yield of 33 percent of the original yield. After cleaning by surging, the specific yield increased to an average of 50 percent of the original yield. The rate of sand infiltration during pumping was insignificant.

24. A summary of pumping test data collected in 1969 and 1970 is shown in table B5. Plots of observed discharge versus drawdown are shown in plates B1-B5. Also shown in the plots are similar data for the original pumping tests made in 1957 and for the final pumping tests made in 1966. Fig. B2 is a comparison of the computed specific yields from the 1969-70 pumping tests with those computed from previous pumping tests. Before the wells were cleaned in 1969-70, their specific yields varied from 0 to 76 percent of their original specific yields and averaged about 33 percent. After the wells had been cleaned, their specific yields varied from 19 to 84 percent of their original specific yields and averaged about 50 percent. In 1966, the specific yields of the wells before they were cleaned averaged 34 percent of their original specific yields. After the wells were cleaned, their specific yields averaged 47 percent of their original specific yields. It can be noted then that the average specific yield of the wells before they were cleaned in 1969-70 was about the same as the average specific yield before they were cleaned in 1966. Also, after the wells were cleaned in 1969-70, their average specific yield was only slightly higher than it was after the wells were cleaned in 1966.

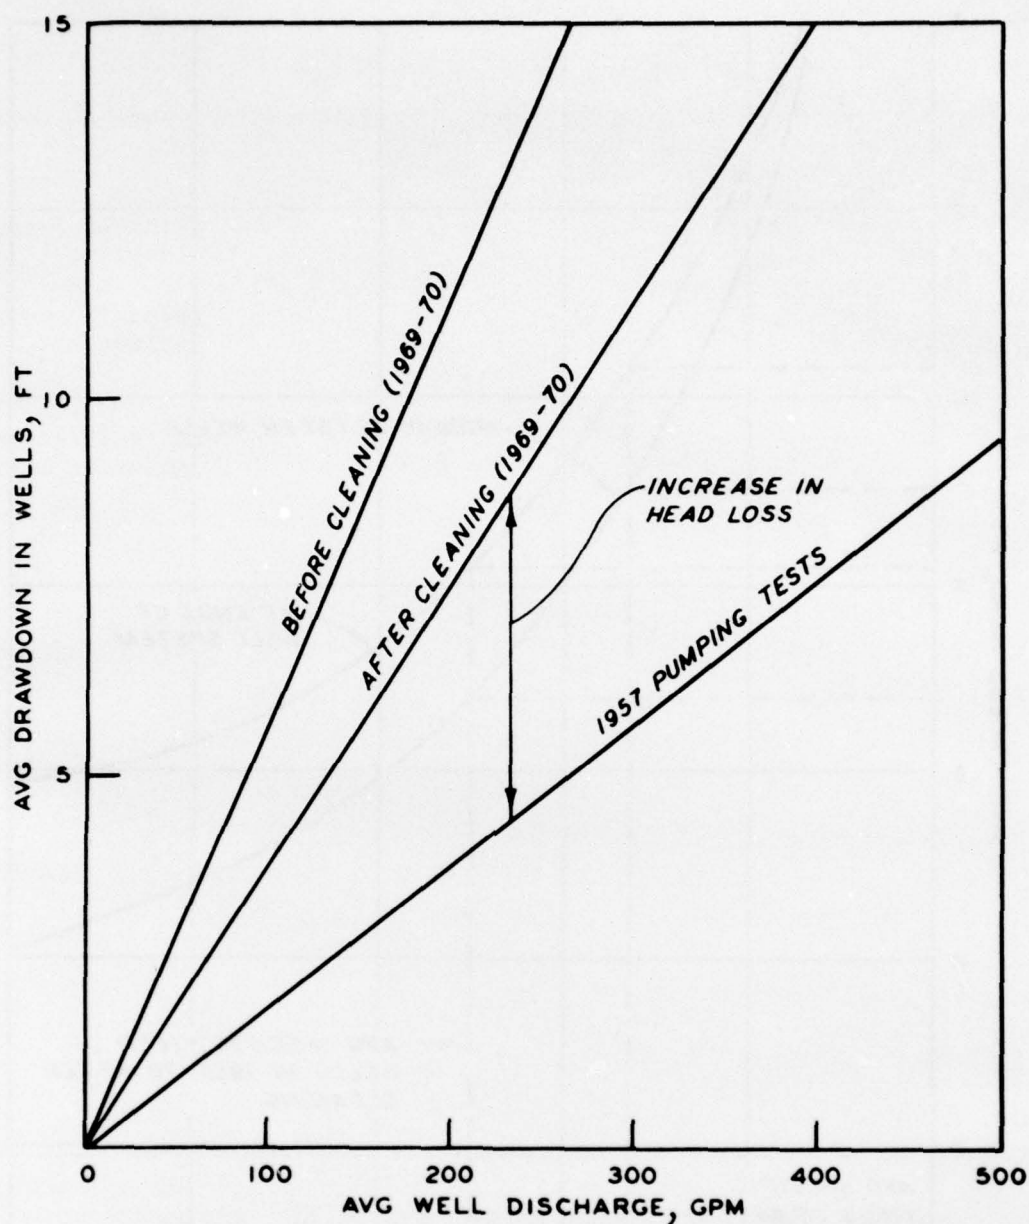
Fig. B3. Head losses due to decrease in average well efficiency

NOTE: AVG SPECIFIC YIELD OF WELLS FROM 1957 PUMPING TESTS = 52.3 GPM/FT DRAWDOWN.

AVG WELL EFFICIENCY FROM 1969-70 PUMPING TESTS

- a) 33% OF 1957 SPECIFIC YIELD BEFORE WELLS CLEANED.
- b) 50% OF 1957 SPECIFIC YIELD AFTER WELLS CLEANED.
